AMENDING AN AGREEMENT WITH ERA VALDIVIA FOR PAINTING AND REPAIR OF THE SOUTH WATER TOWER IN THE AMOUNT OF \$440,000.

On April 8, 2020 Dixon Engineering Inc. performed a maintenance inspection on the 2,000,000 gallon fluted column (South) elevated water storage tank owned by the City of DeKalb. Purposes of the inspection were to evaluate the interior and exterior coating's performance and life expectancy, assess the condition of metal surfaces and appurtenances, review safety and health aspects, and make budgetary recommendations for continued maintenance of the tank. All recommendations with budgeting estimates for repairs are incorporated in this report.

2,000,000 gallon fluted column water storage tank (South) located in DeKalb, Illinois.

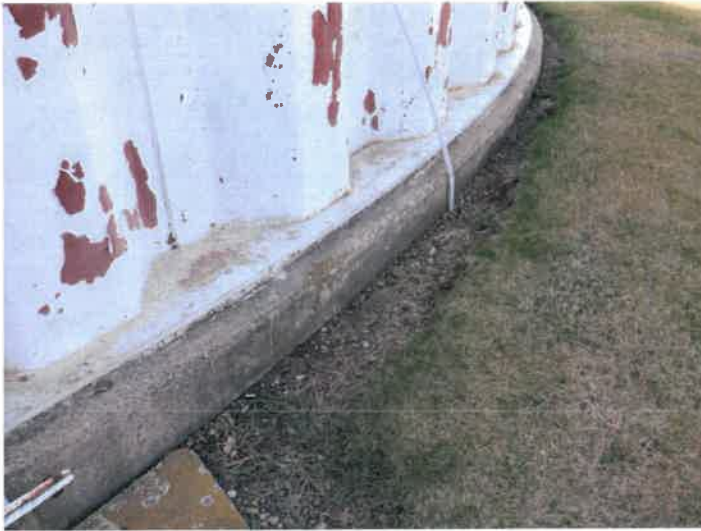
The exposed concrete foundation is in good condition. There is minor deterioration with some cracking. The cracks are not significant enough to create a structural problem. The top of the exposed foundation is coated.

1) Minor crack in the concrete foundation.

Recoat the exposed concrete with an epoxy coating system to help prevent further deterioration. The cost would be incidental to exterior painting.

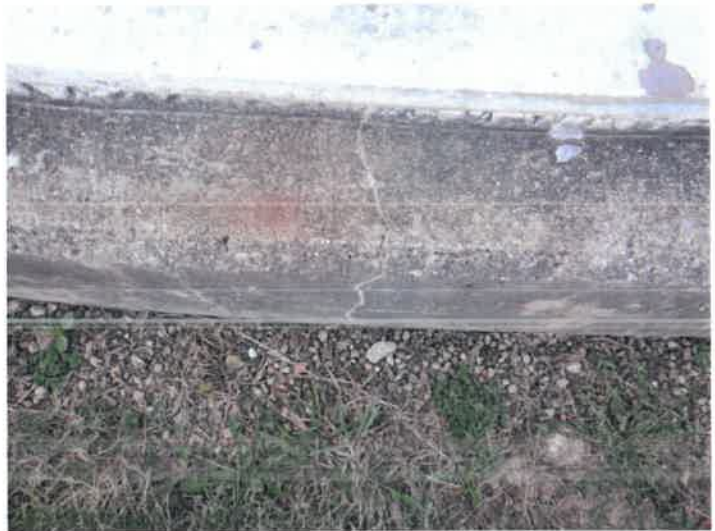
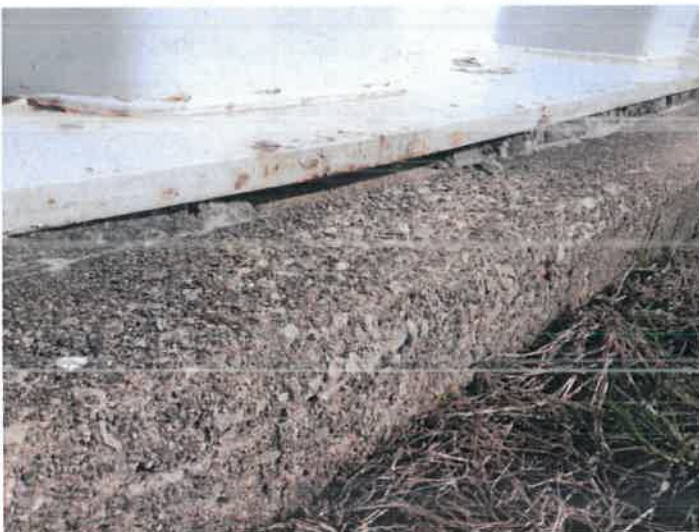
The grout between the baseplate and the foundation is in good condition with approximately 6 total lineal feet missing.

3) Missing grout between the tank baseplate and foundation.

The purpose of the grout is to evenly distribute the load onto the foundation and to prevent water from getting between the foundation and the tank. Repair areas of missing or damaged grout between the steel baseplate and the concrete foundation. The cost would be incidental to the next painting project.

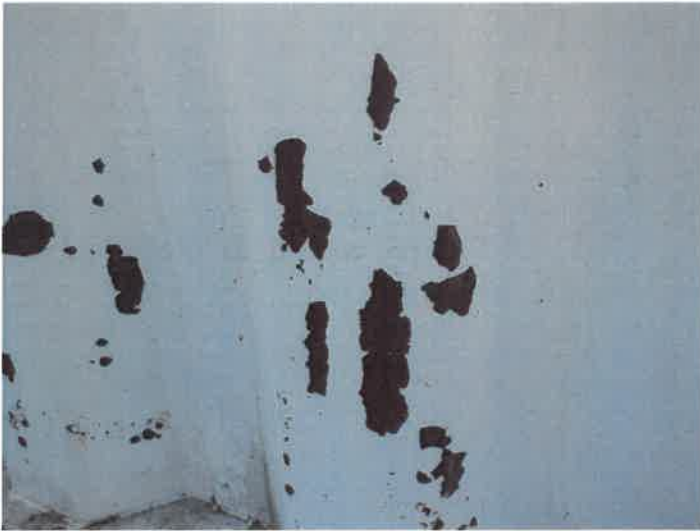
The column coating is in poor condition with numerous failures. Primary methods of deterioration are spot failures to the substrate with rust undercutting, rust bleedthrough, and delaminated topcoat.

4) Coating delamination on the column.

The recommended procedure is to high pressure water clean (5,000-10,000 psi) the exterior to remove any poorly adhered coating and any contaminants. Coating failures to the substrate would be spot power tool cleaned to bare metal (SSPC-SP11) condition. All sharp edges would be feathered into the surrounding coating.

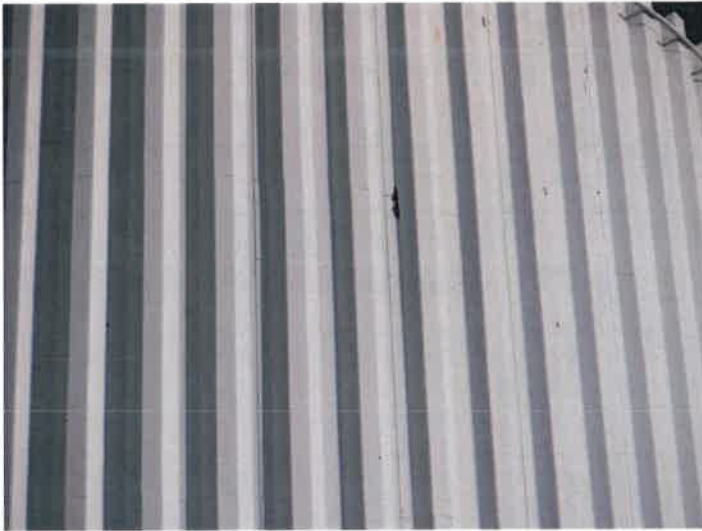
7) Spot coating failure on the column.

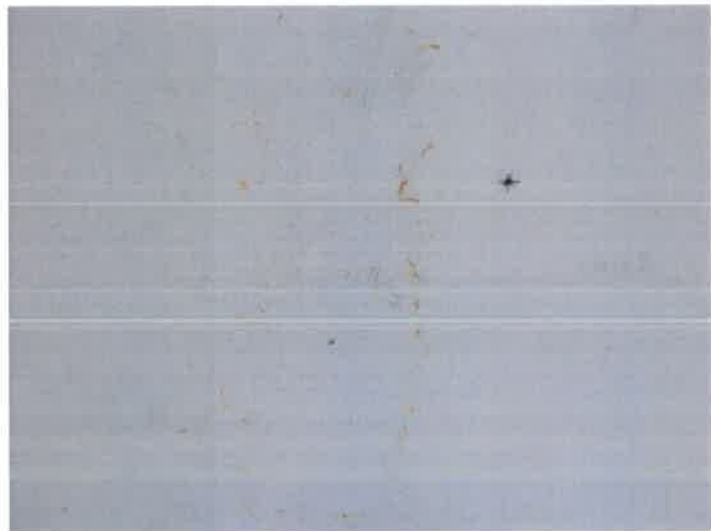
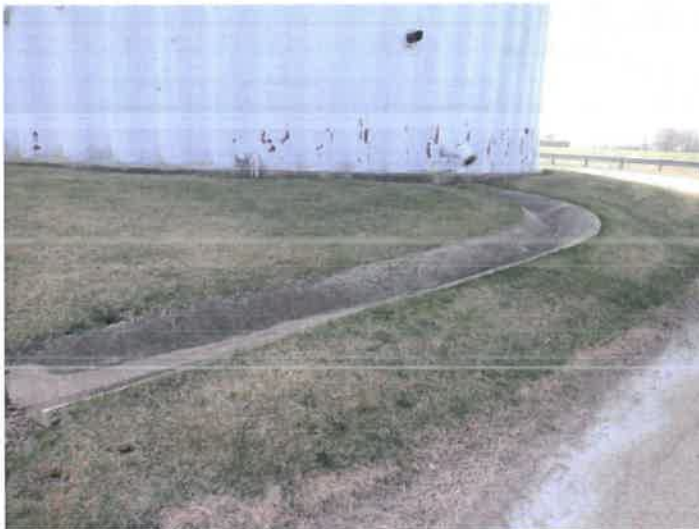
8) Rust bleedthrough on the column.

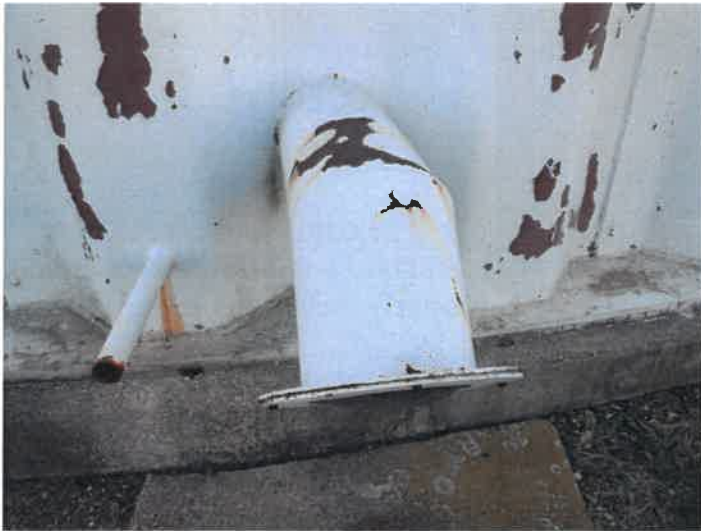
10) Coating failures on the overflow pipe.

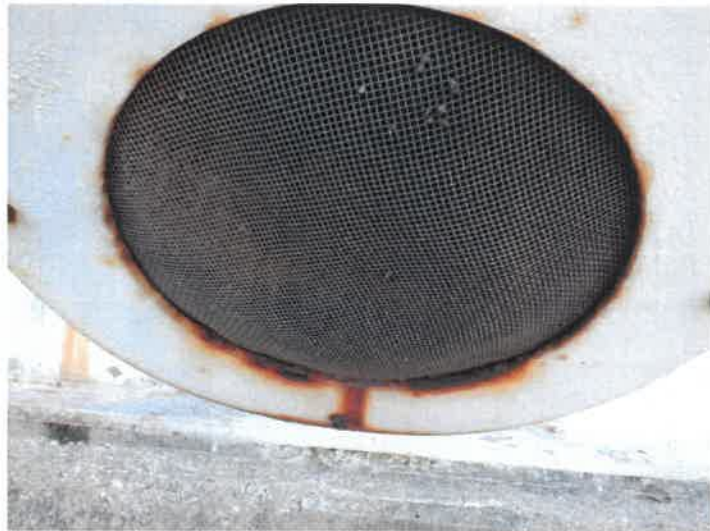
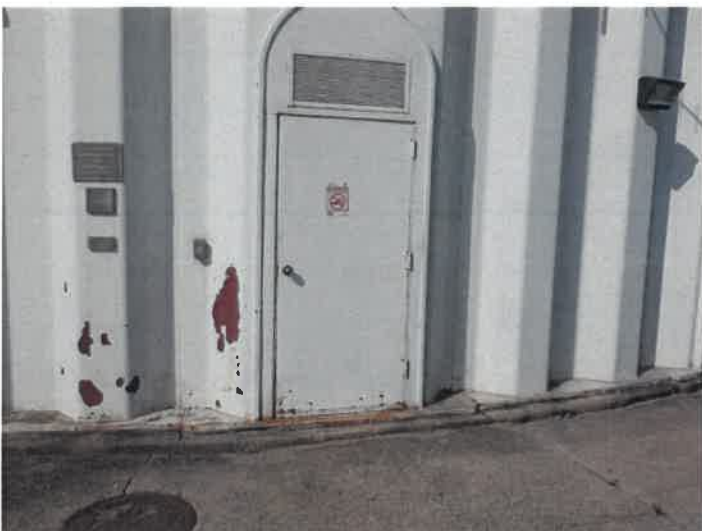
The overflow pipe extends along the access tube in the wet interior down through the dry riser and exits near the bottom of the column. The discharge end of the overflow pipe is screened. The screen is in good condition but is oversized. The pipe discharges to a concrete trough. There is a crack in the concrete trough. The air gap meets the required 12-24 inches. The discharge area is in good condition.

11) The screen on the overflow discharge is in good condition but is oversized.

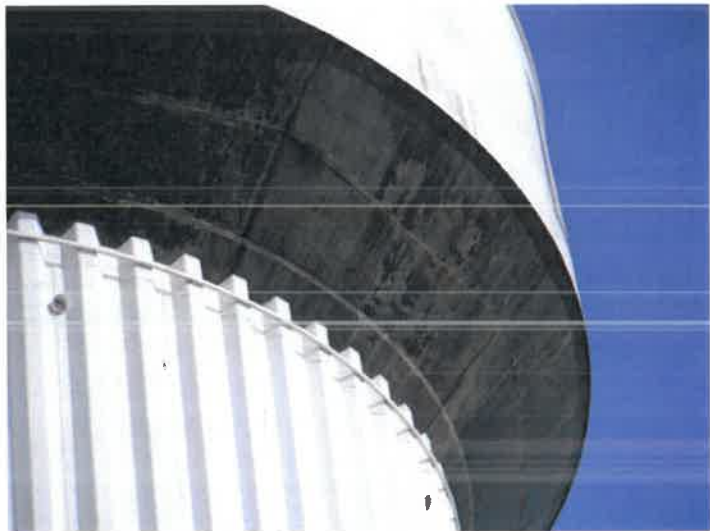
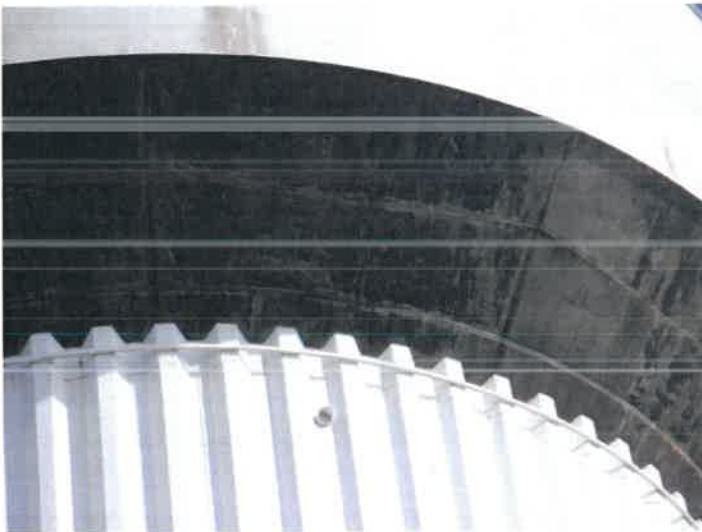
The bowl coating is in fair condition with a few failures. Primary method of deterioration is spot failures to the substrate.

14) There are spot coating failures on the bowl. The bowl is covered with mildew.

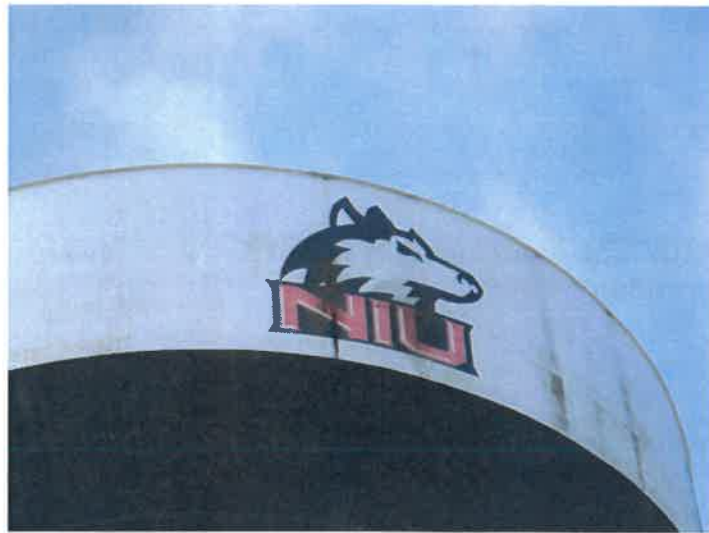
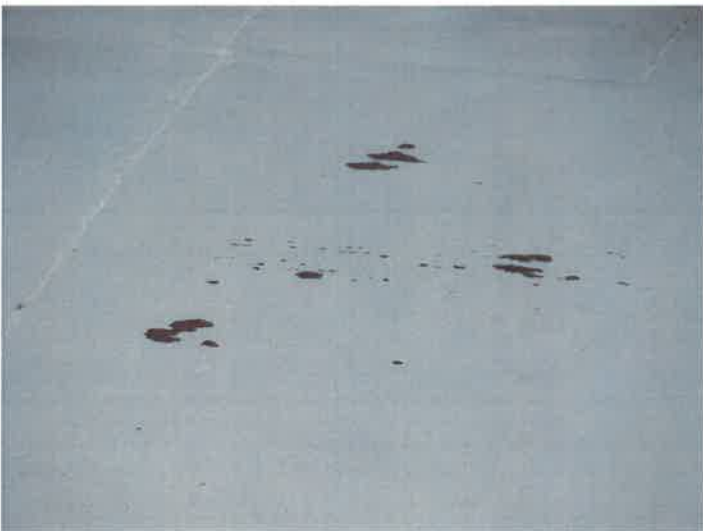
The sidewall coating is in fair condition with a few failures. Primary method of deterioration is delaminated topcoat. There is lettering that states "DEKALB" on the sidewall in two locations. There is a wolf logo on the sidewall with the letters NIU below in one location.

16) Coating delamination on the sidewall.

17) The sidewall coating has faded

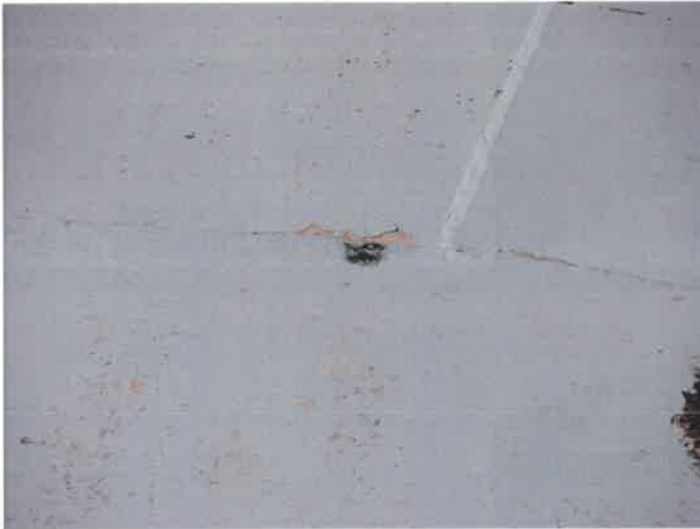
The roof coating is in poor condition with numerous failures. Primary methods of deterioration are spot failures to the substrate with rust undercutting and delaminated topcoat.

18) Coating delamination and spot coating failures on the roof.

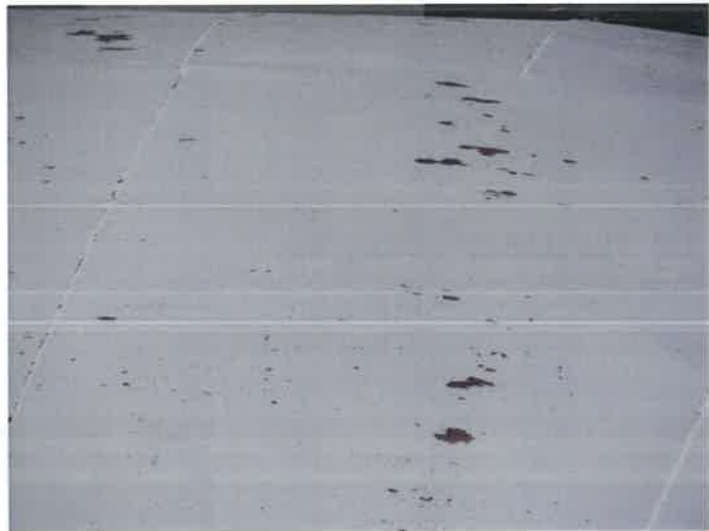
19) Spot coating failures on the roof.

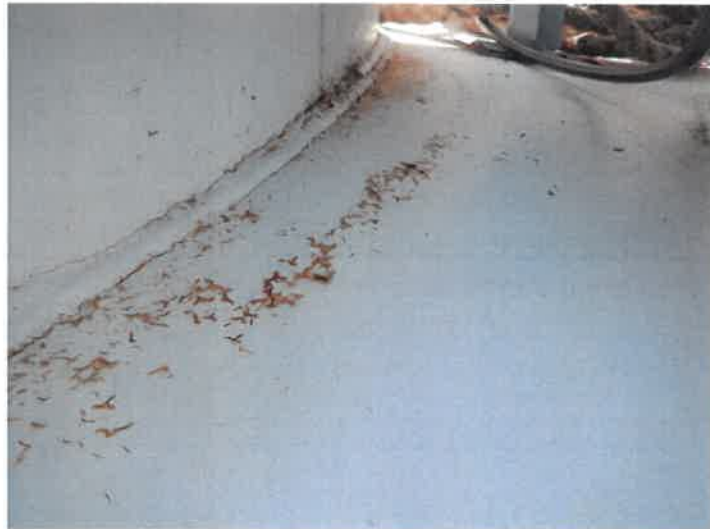
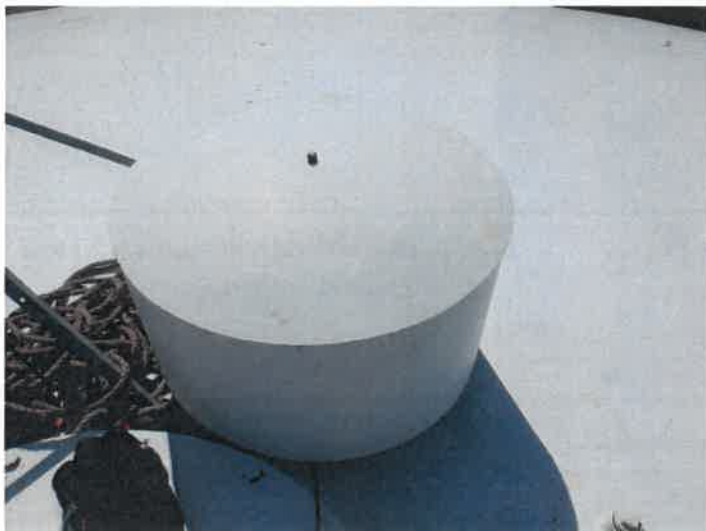
22) Topcoat delamination on the roof.

23) Rust undercutting on the roof coating near the vent.

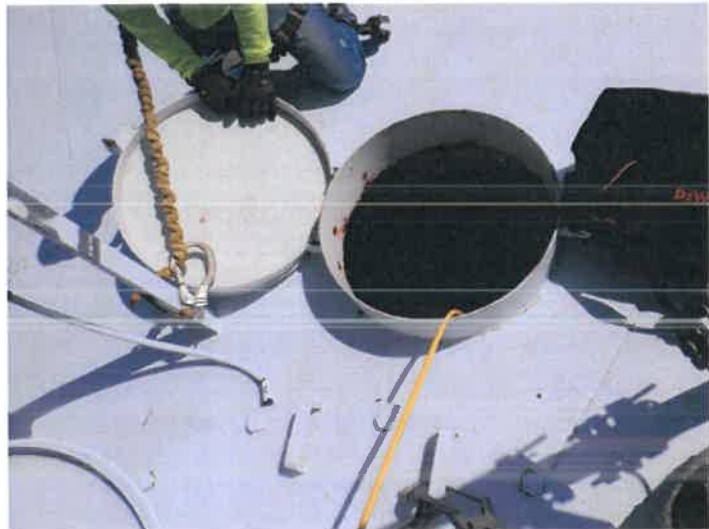
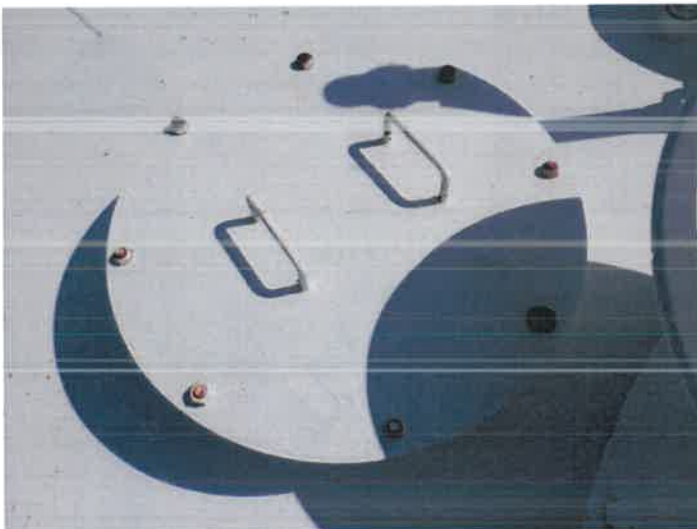
The roof vent is flow through design that is in fair condition. The screen is in good condition but the mesh size is larger than the recommended 24 mesh. This is a possible entry point for insects, though none were observed inside the tank.

25) The roof vent screen is in good condition but is oversized.

Replace the roof vent with a screened pressure vacuum vent to meet current Illinois EPA requirements. The new vent would have a movable plate that would allow air to flow in and out of the tank even if the screens become plugged or frosted over. The vent would have a rain shield to prevent rainwater from entering the storage tank during high winds. The estimated cost is \$6,000.

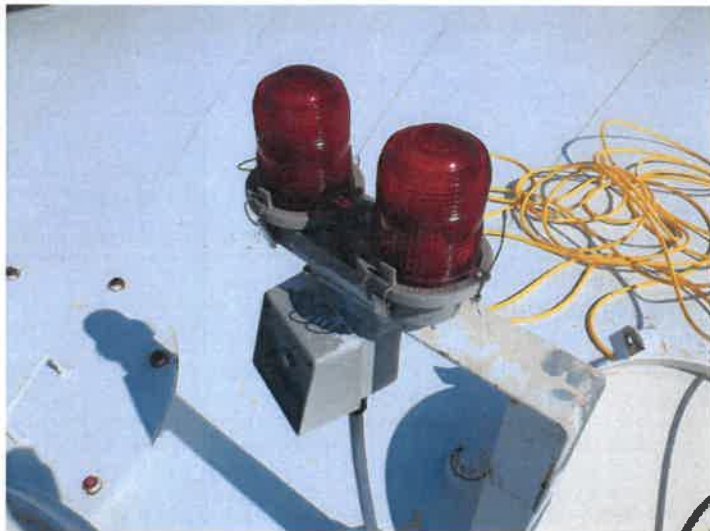
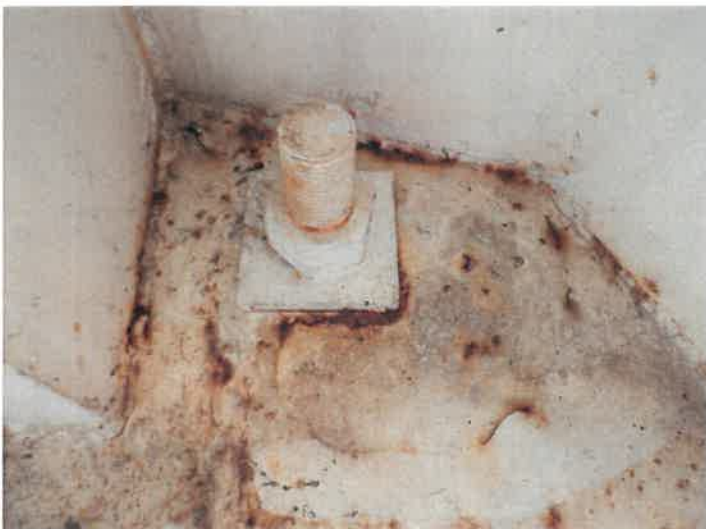
The tank has a double aviation light on the roof that is in good condition. There is a photocell that will switch the lights on when it's dark outside. It could not be determined if the lights are operational. The photo cell was covered by the inspector, but the light did not turn on. Sometimes the photo cell will not switch the light on until it has been dark for several minutes.

29) The double aviation light appears to be in good condition but did not operate during the inspection.

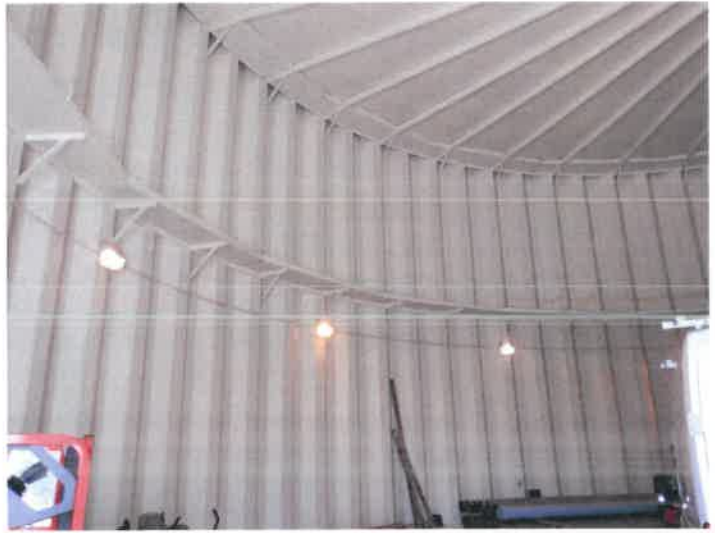
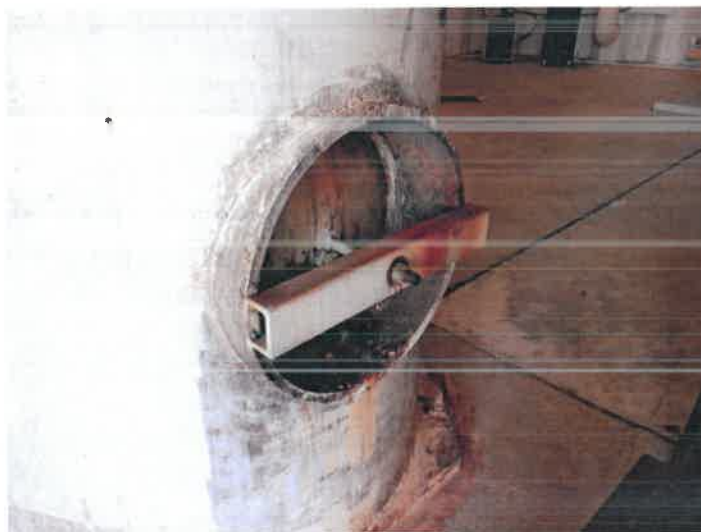
The column below the condensate platform is in good condition with only a few failures. Primary method of deterioration is spot failures to the substrate with rust undercutting. Most of the coating failures are on the baseplate.

31) Spot coating failure on the baseplate in the dry interior.

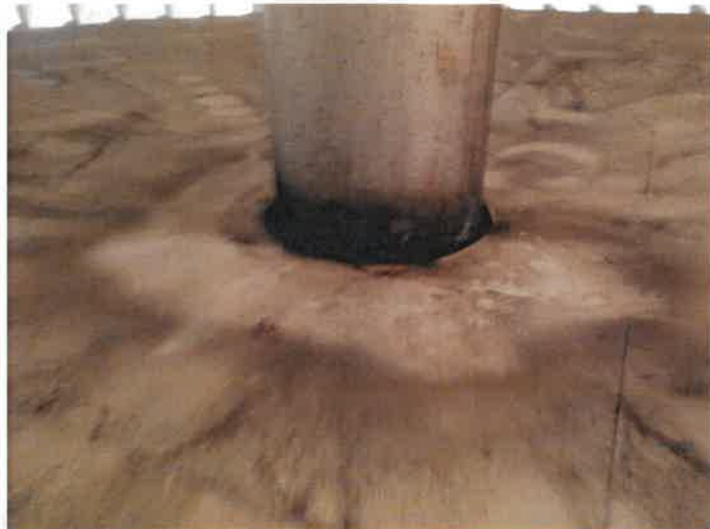
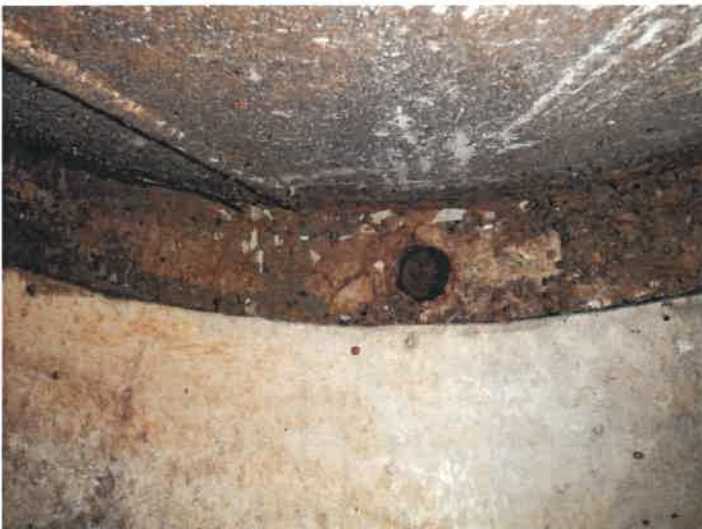
35) Spot coating failures on the condensate platform.

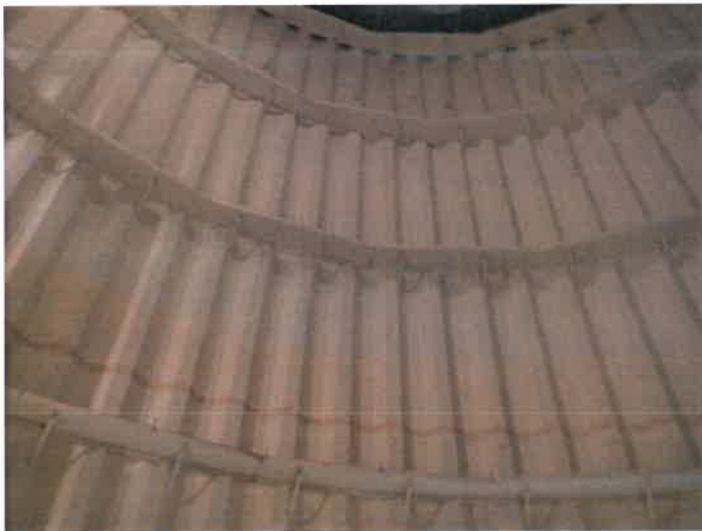
36) Coating failures around the condensate drain.

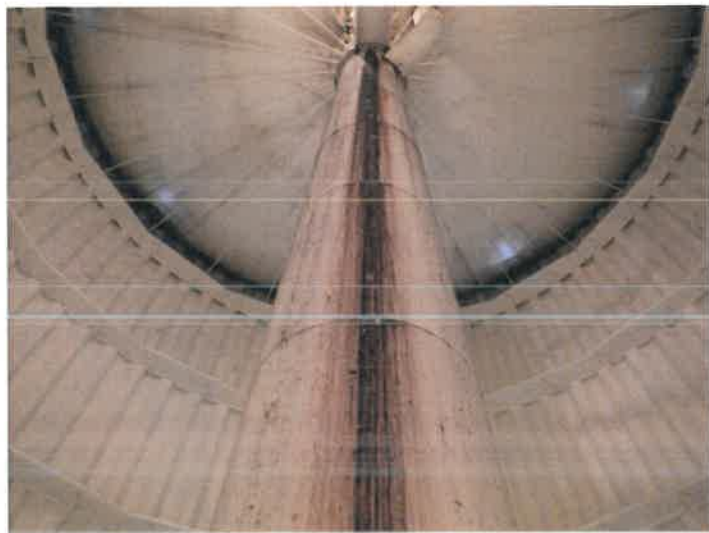
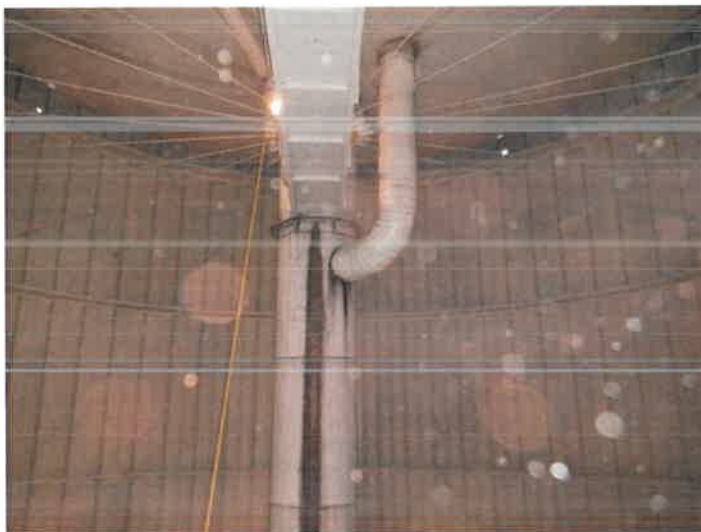
38) Spot coating failures on the wet riser.

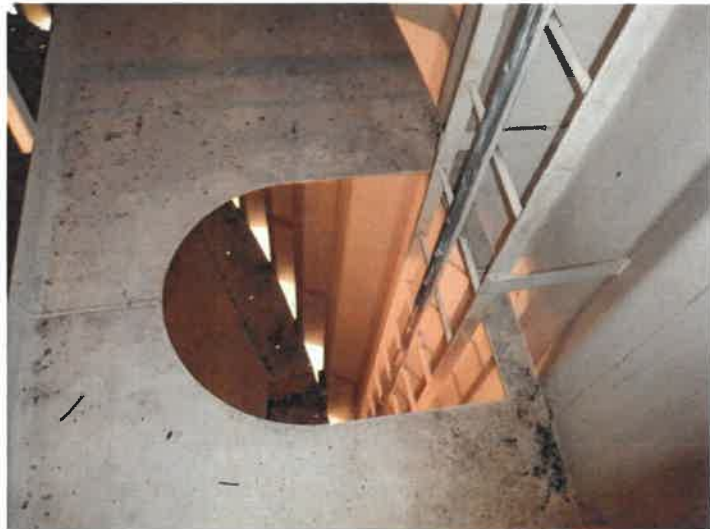
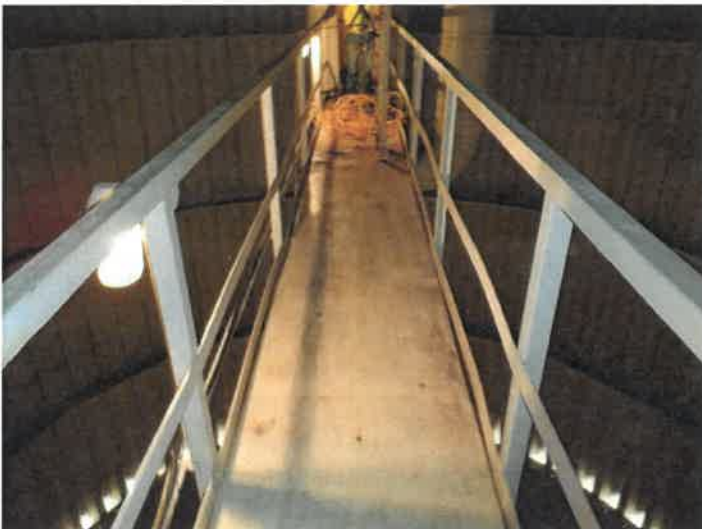
41) There is no cover over the hatch in the top platform.

13. Replace the access tube roof hatch with a 30 inch diameter hatch. The estimated cost is \$4,000.
14. Install a hinged cover over the ladder opening at the top platform. The estimated cost is \$4,000.

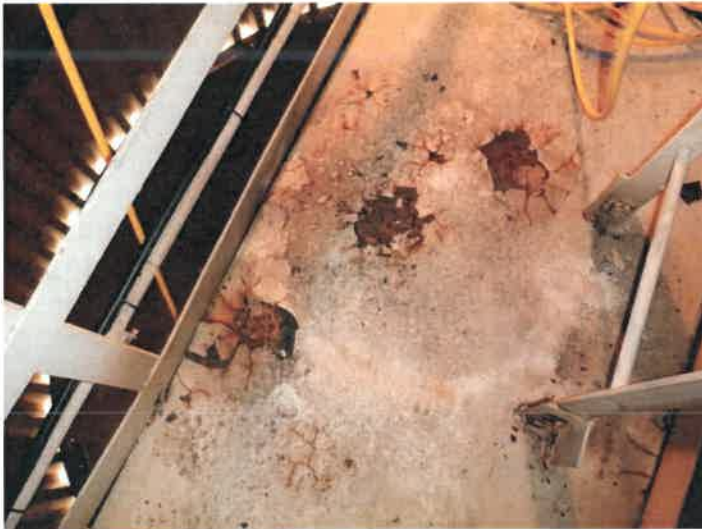
The coating on the topside of the platforms is in fair condition with numerous failures. Primary method of deterioration is spot failures to the substrate with rust undercutting.

42) Spot coating failures on the top platform.

Spot abrasive blast clean the dry interior to a commercial (SSPC-SP6) condition including the topside of the platforms, the entire access tube, and other areas of failed coating. The prepared surfaces would be coated with an epoxy system. The work should be performed with an exterior/wet interior painting project. The estimated cost is \$40,000.

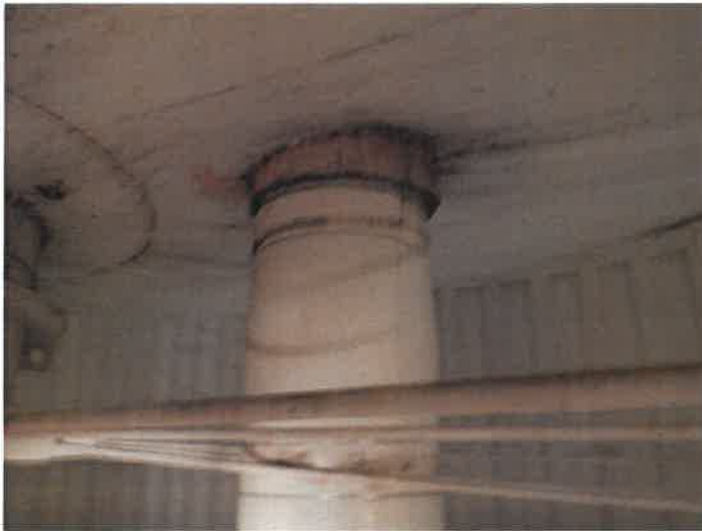
The bowl coating is in fair condition with a few failures. Primary method of deterioration is spot failures to the substrate with rust undercutting.

45) Spot coating failure with rust undercutting on the bowl.

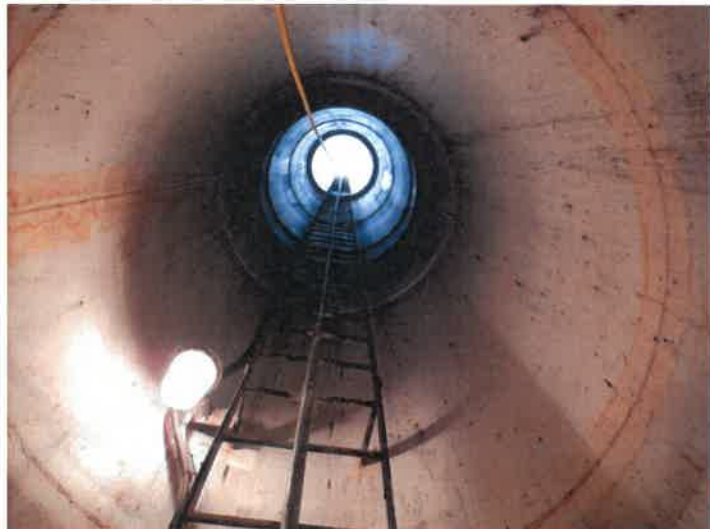
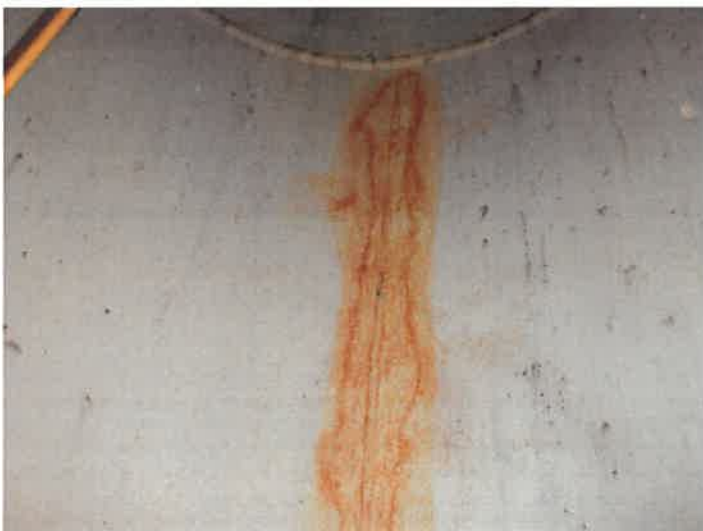
The access tube coating is in poor condition with numerous failures. Primary methods of deterioration are spot failures to the substrate and rust bleedthrough.

47) The access tube coating is in poor condition overall.

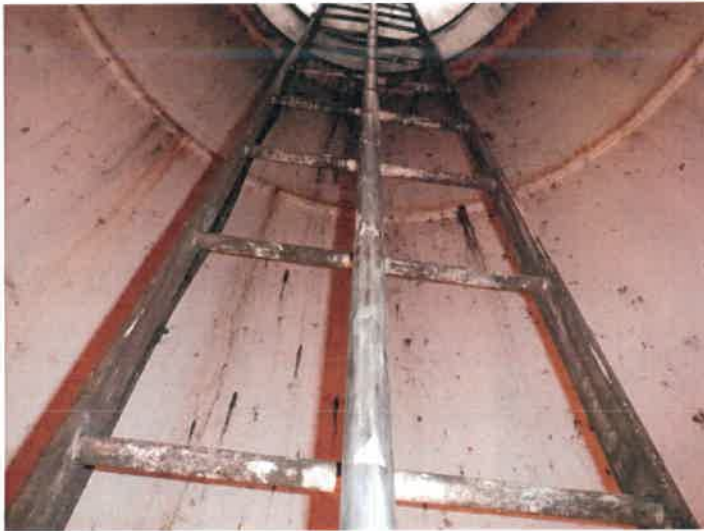
48) Spot coating failures and rust bleedthrough in the access tube.

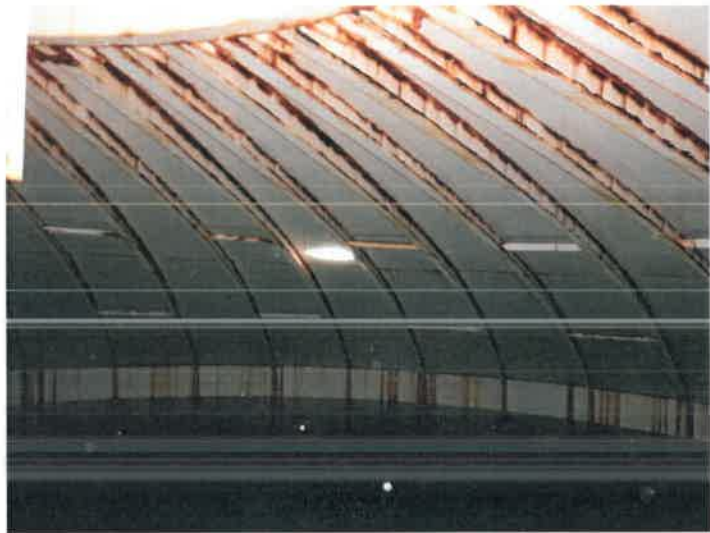
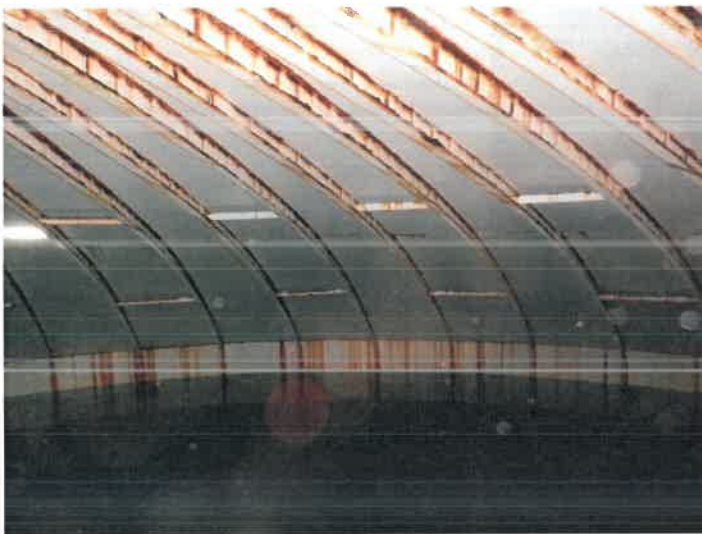
The roof coating is in poor condition with extensive failures. Primary methods of deterioration are spot failures to the substrate with rust undercutting and rust bleedthrough. There are minor coating failures on the roof panels but most of deterioration is along the open lap seams, at the gap between the roof stiffeners and roof plate, and on the stiffeners. The roof contains open lap seams that have started to rust and streak. Rusting is typical for a roof where the lap seams are open and not seal welded. The presence of rust in the lap seams is not a concern but should be monitored during future inspections for additional corrosion growth. Corrosion on the roof stiffeners is typical but should be corrected before structural loss of steel occurs.

50) Coating failures on the wet interior roof.

Abrasive blast clean the wet interior roof to a near-white metal (SSPC-SP10) condition and apply a three-coat epoxy system. The estimated cost is \$150,000.

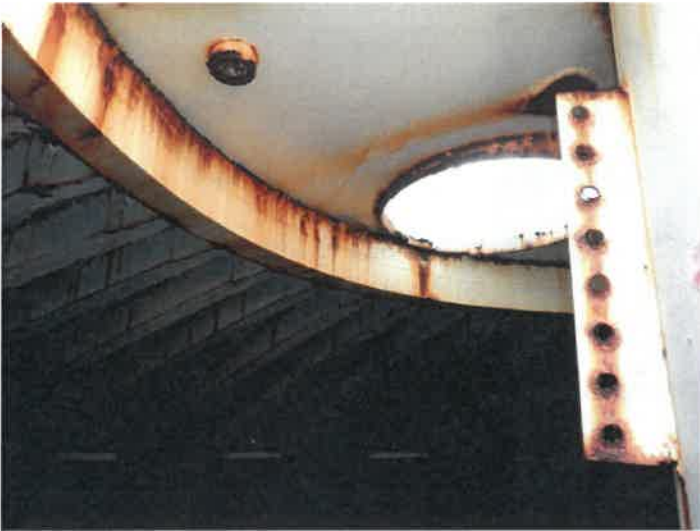
51) Same.

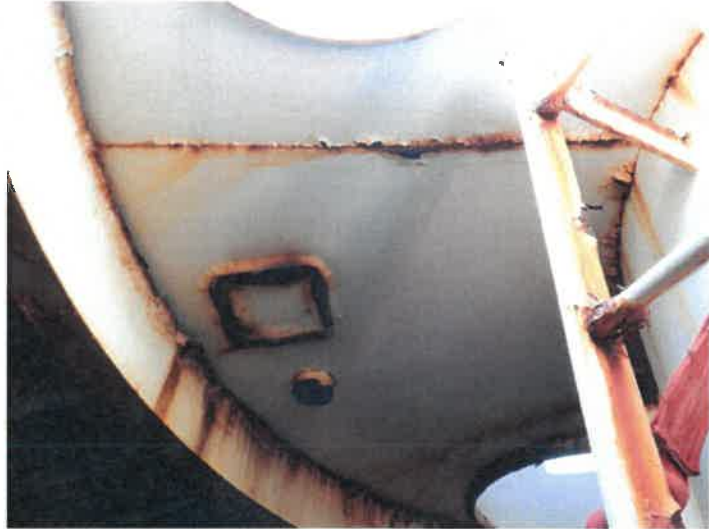
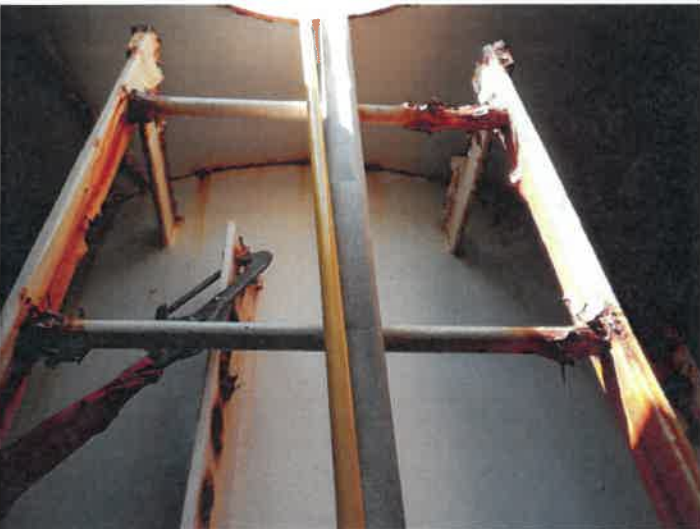
52) Spot coating failures and minor corrosion on the wet interior roof.

53) Weld burn on the wet interior roof.

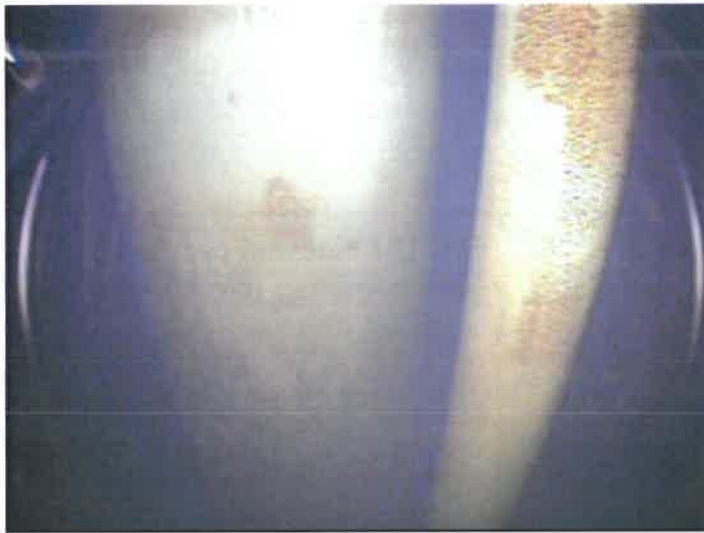
60) Spot coating failures on the upper access tube and overflow pipe.

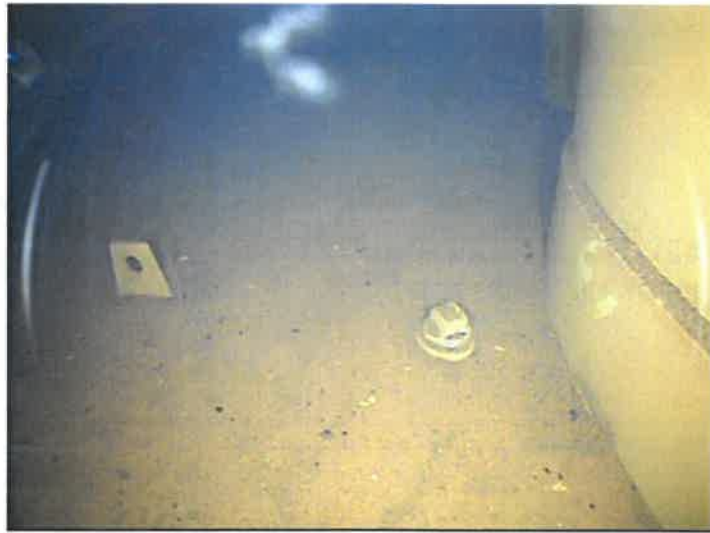
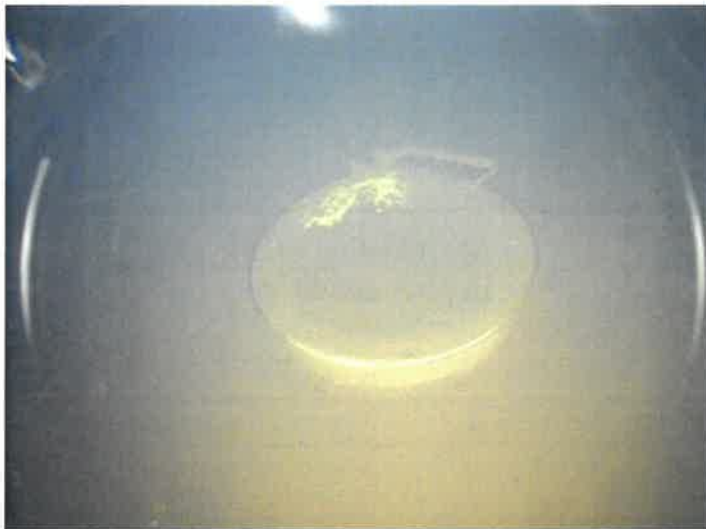
The bowl was covered with approximately 2 inches of sediment that limited the amount of surface visible with the ROV. The coating on the visible surface is in good condition with no significant deterioration.

64) The bowl is covered with sediment.

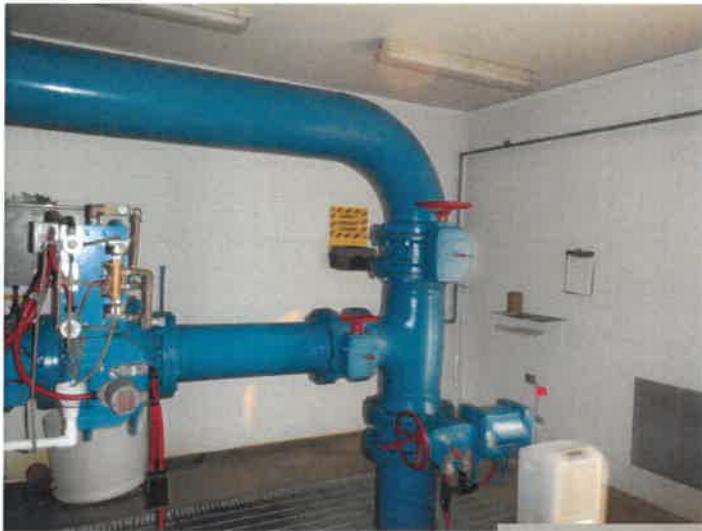
There is a pit the base of the column that contains piping. The pit has a metal hatch that is in fair condition. The piping is in good condition. The coating on the piping is in poor condition with extensive coating failure.

69) Coating on the pit piping is in poor condition.

Abrasive blast clean the pit piping to a commercial (SSPC-SP6) condition and repaint with an epoxy system. The estimated cost is \$4,000.
