AMENDING AN AGREEMENT WITH ERA VALDIVIA FOR PAINTING AND REPAIR OF THE SOUTH WATER TOWER IN THE AMOUNT OF \$440,000.

On April 8, 2020 Dixon Engineering Inc. performed a maintenance inspection on the 2,000,000 gallon fluted column (South) elevated water storage tank owned by the City of DeKalb. Purposes of the inspection were to evaluate the interior and exterior coating's performance and life expectancy, assess the condition of metal surfaces and appurtenances, review safety and health aspects, and make budgetary recommendations for continued maintenance of the tank. All recommendations with budgeting estimates for repairs are incorporated in this report.

2,000,000 gallon fluted column water storage tank (South) located in DeKalb, Illinois.

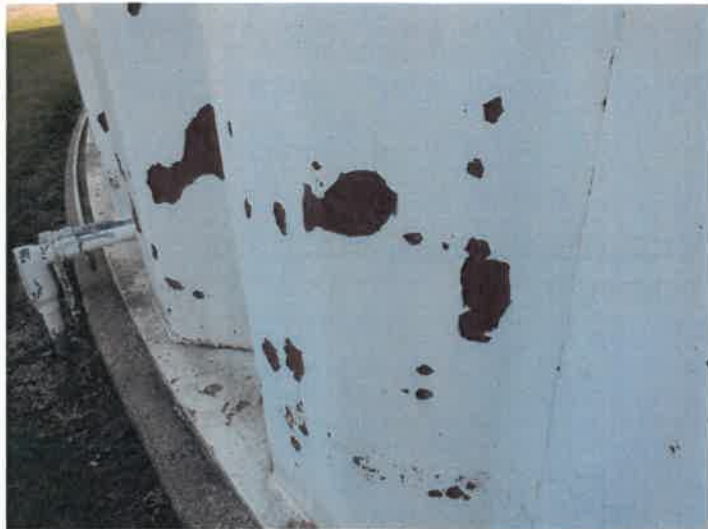
The column coating is in poor condition with numerous failures. Primary methods of deterioration are spot failures to the substrate with rust undercutting, rust bleedthrough, and delaminated topcoat.

5) Same.

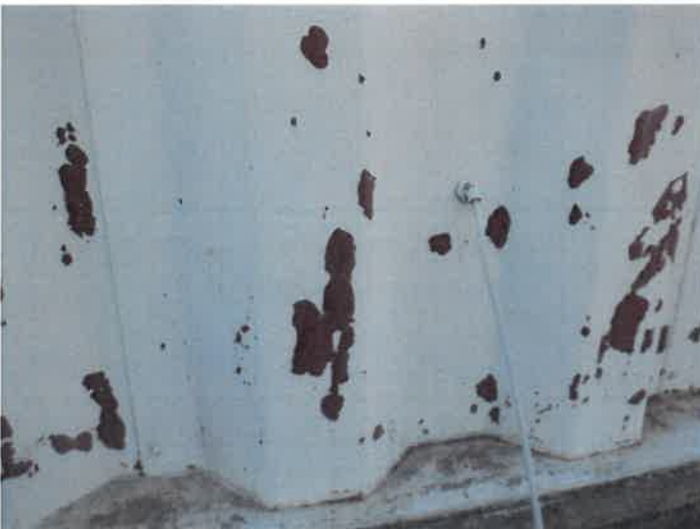
6) Same.

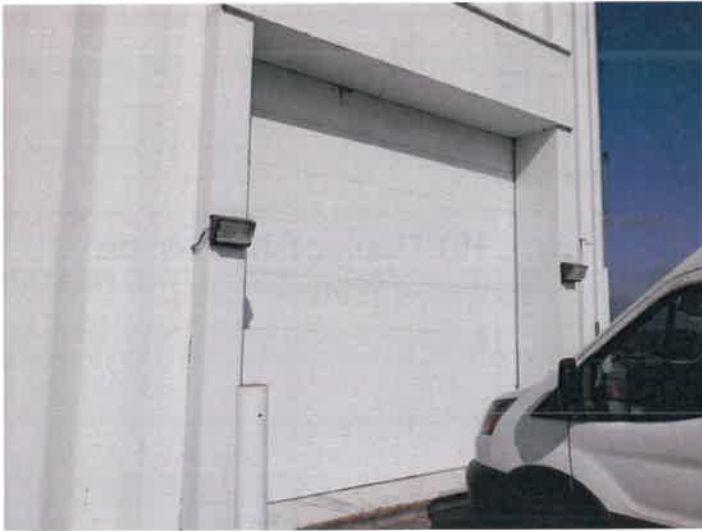
13) The column overhead door is in good condition and operated properly during the inspection.

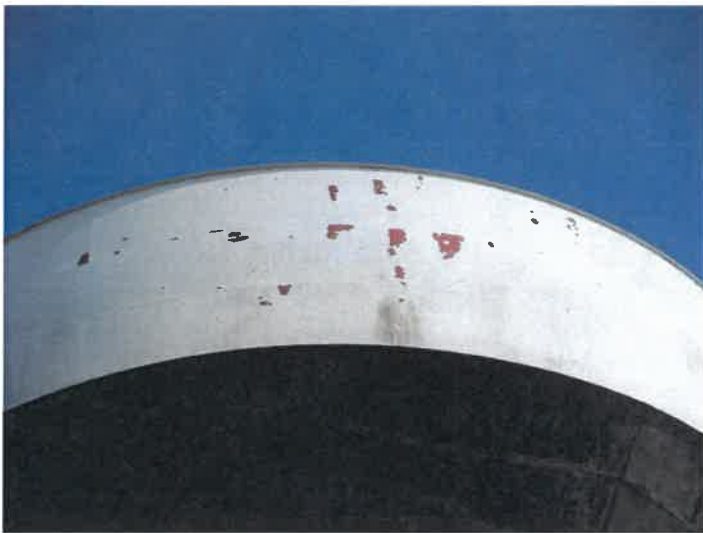
The sidewall coating is in fair condition with a few failures. Primary method of deterioration is delaminated topcoat. There is lettering that states "DEKALB" on the sidewall in two locations. There is a wolf logo on the sidewall with the letters NIU below in one location.

16) Coating delamination on the sidewall.

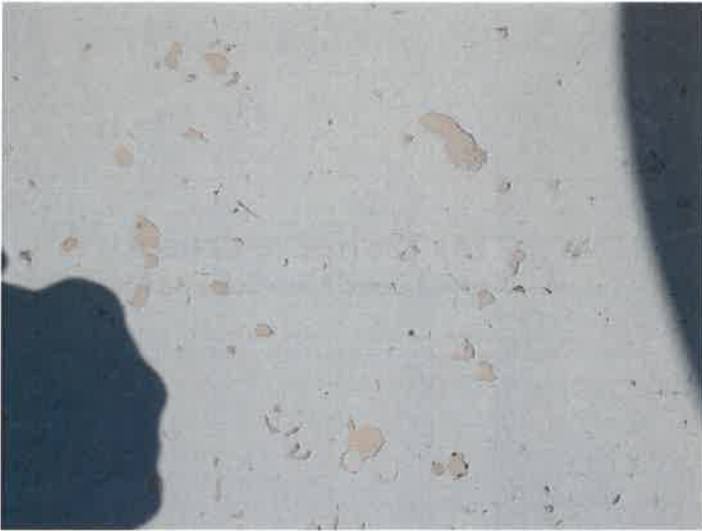
The roof coating is in poor condition with numerous failures. Primary methods of deterioration are spot failures to the substrate with rust undercutting and delaminated topcoat.

22) Topcoat delamination on the roof.

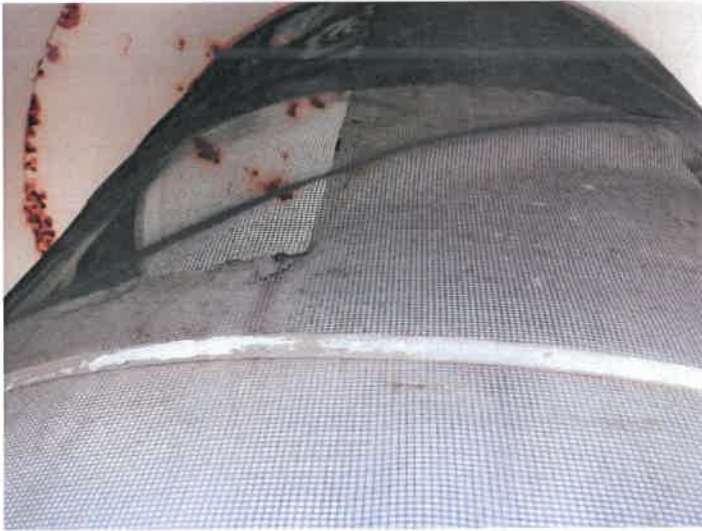
25) The roof vent screen is in good condition but is oversized.

15. Replace the roof vent with a pressure vacuum vent to meet current Illinois EPA requirements. The estimated cost is \$6,000.
16. Adjust the fall prevention device on the wet interior ladder. The cost would be incidental to the next painting project.

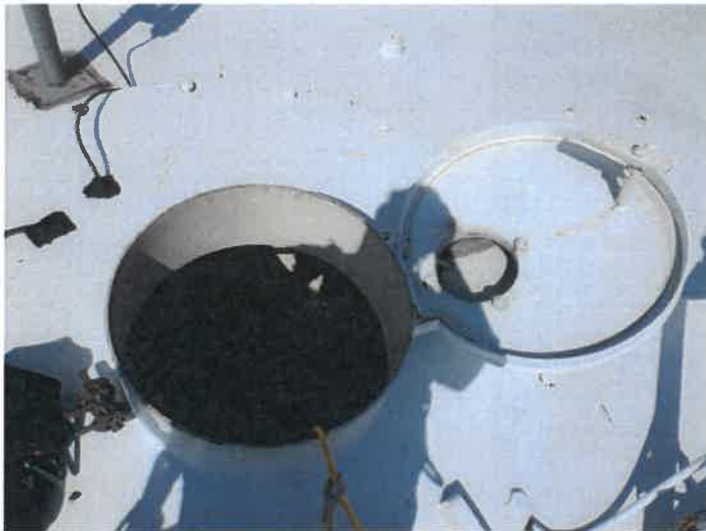
28) The access tube hatch is in fair condition.

13. Replace the access tube roof hatch with a 30 inch diameter hatch. The estimated cost is \$4,000.
14. Install a hinged cover over the ladder opening at the top platform. The estimated cost is \$4,000.

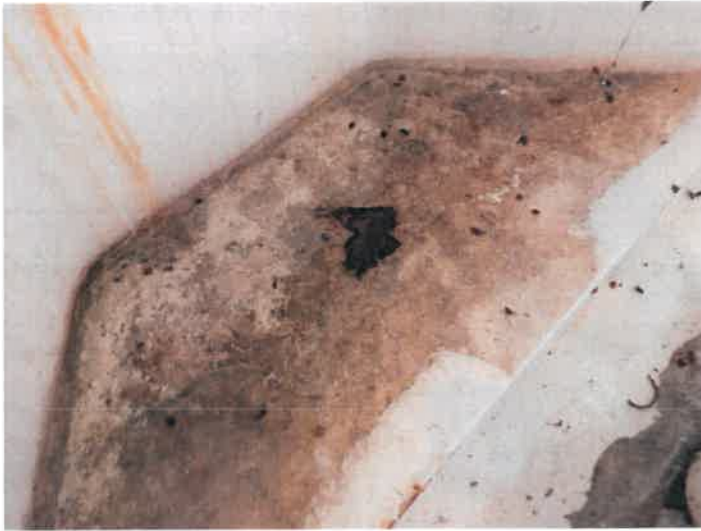
31) Spot coating failure on the baseplate in the dry interior.

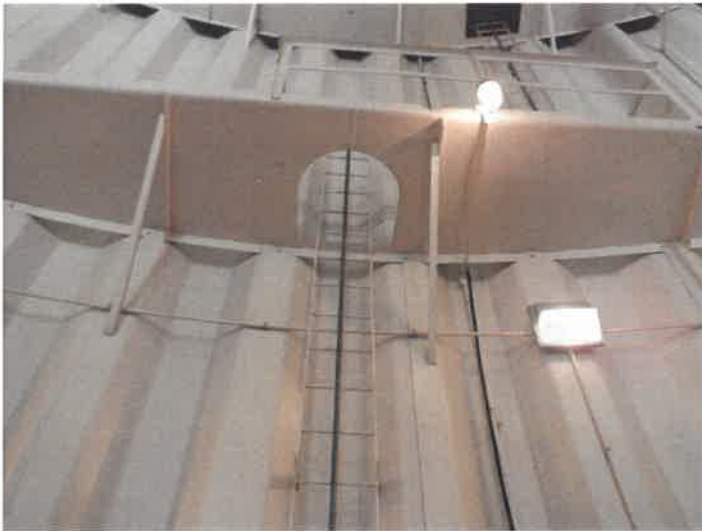
34) The dry interior column ladders below the top platform are in good condition.

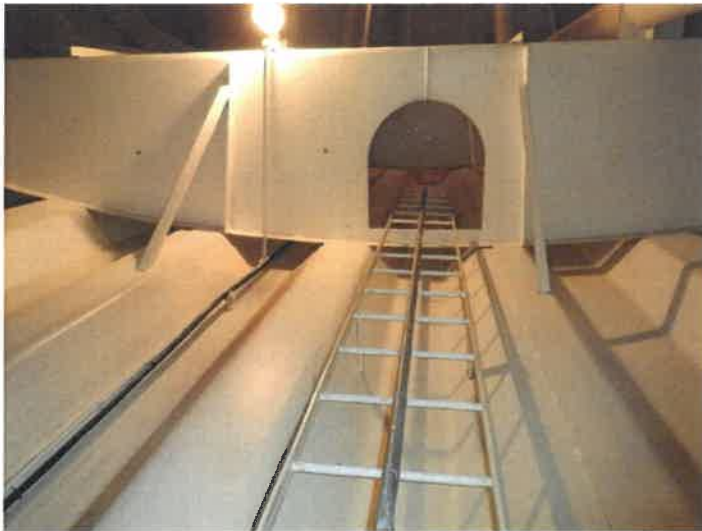
40) The dry interior column ladders above the condensate platform are in good condition.

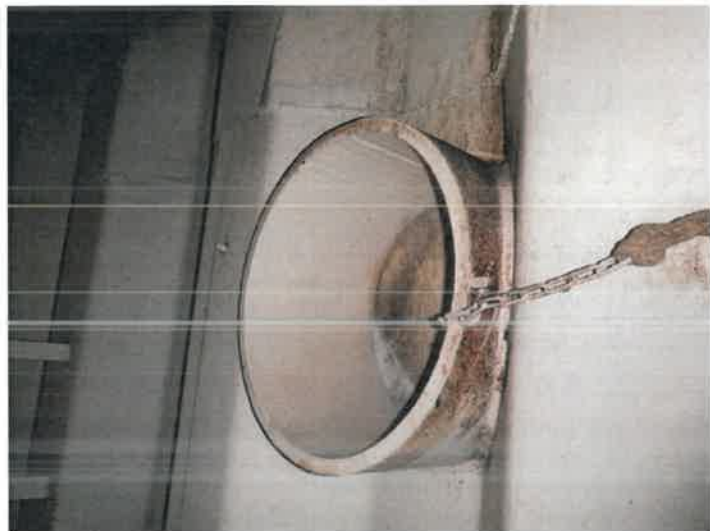
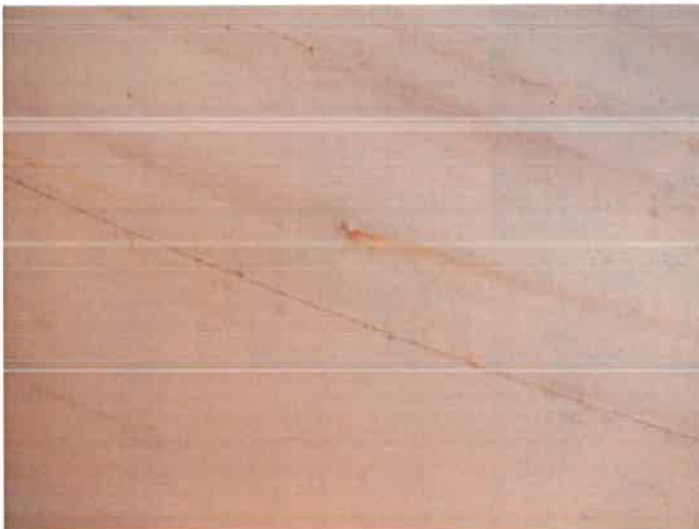
45) Spot coating failure with rust undercutting on the bowl.

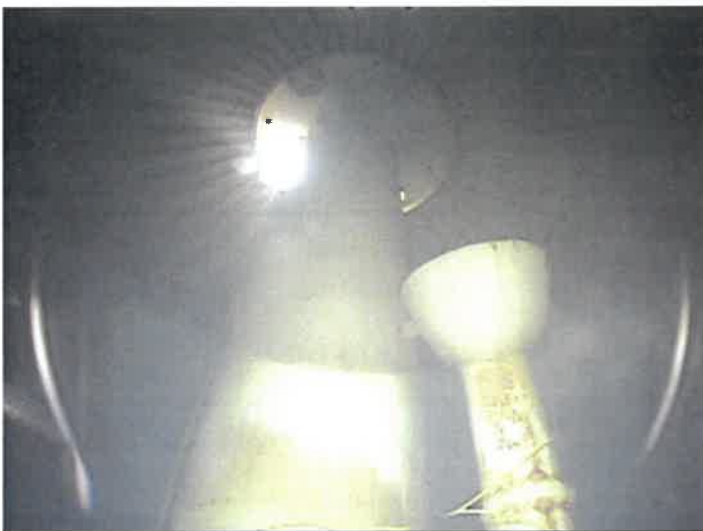
60) Spot coating failures on the upper access tube and overflow pipe.

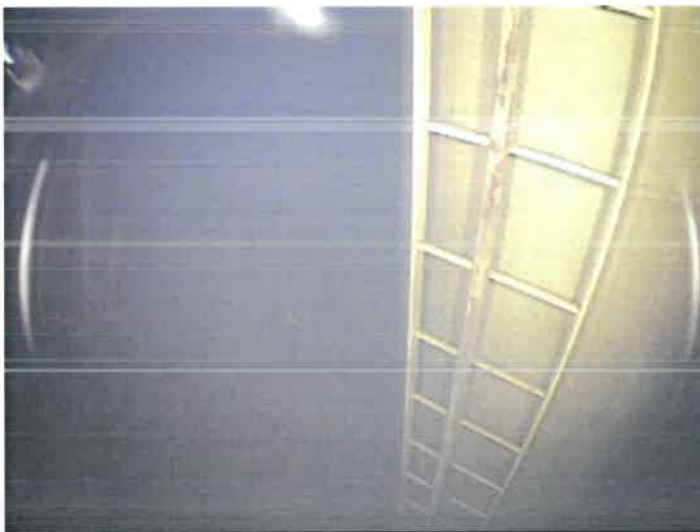
63) The wet interior ladder is in fair condition.

17. Replace the deteriorated wet interior ladder rungs above the high-water level. The estimated cost is \$1,000.

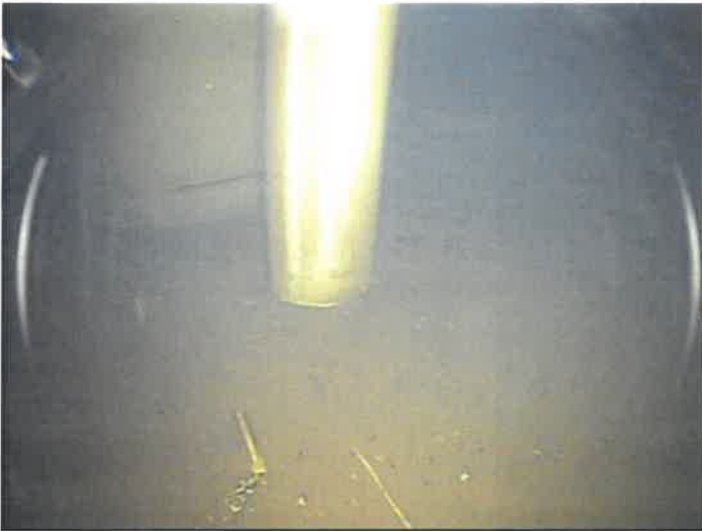
64) The bowl is covered with sediment.

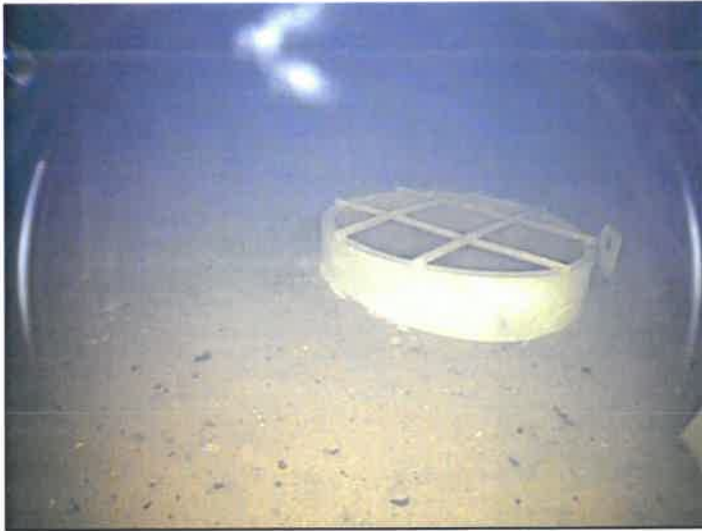
67) The fill/draw pipe is in good condition.

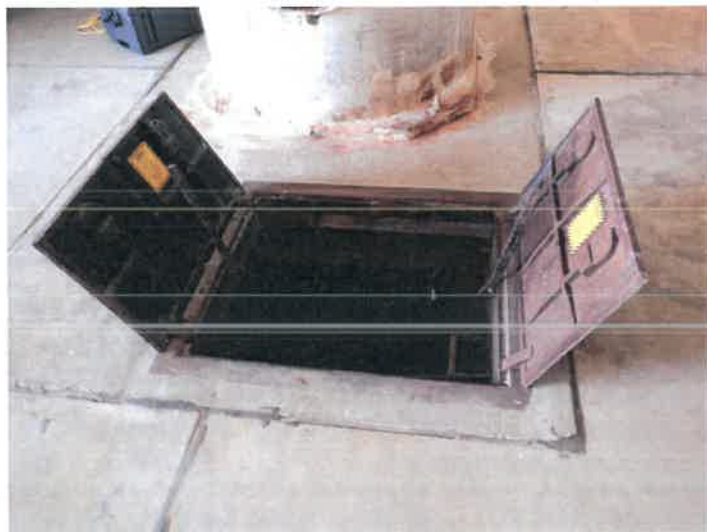
68) There is a metal cover to the pit that is in fair condition.

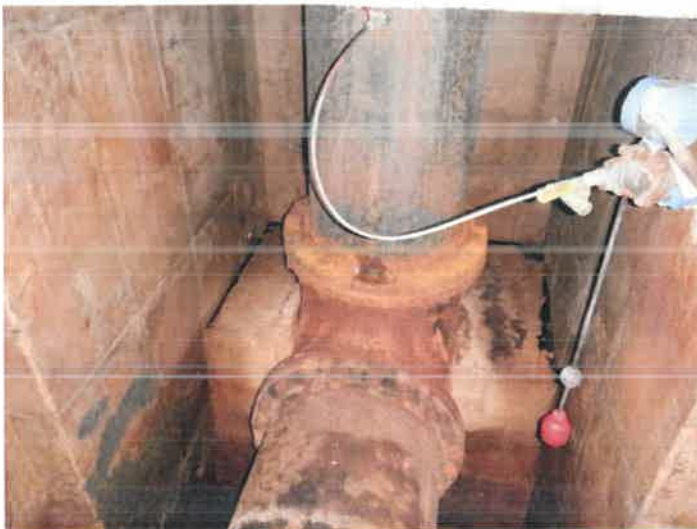
69) Coating on the pit piping is in poor condition.

1. High pressure water clean and overcoat the exterior with a urethane system. The estimated cost is \$350,000.
2. Spot abrasive blast clean the topside of the platforms, the entire access tube, and other spot coating failures in the dry interior. Spot repaint all prepared surfaces with an epoxy coating system. The estimated cost is \$40,000.
3. Abrasive blast clean the wet interior roof and repaint with an epoxy system. The estimated cost is \$150,000.
4. As an alternate, abrasive blast clean the entire wet interior and repaint with an epoxy system. The estimated cost is \$350,000.
5. Install a suspended ring, impressed current cathodic protection system in the wet interior. The estimated cost is \$30,000.
6. Abrasive blast clean the pit piping and repaint with an epoxy system. The estimated cost is \$4,000.
